Project No. 19-012

## Stone Lodge

Critical Conditions Report

JULY 2019

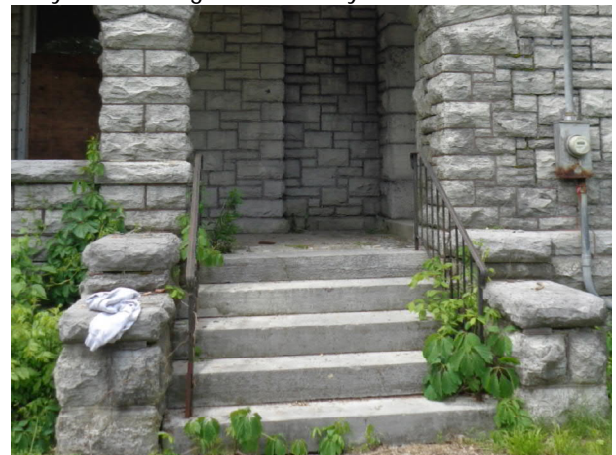
Both of the porch stone stairs are in fair condition. One of the stone treads on the south elevation is cracked. mortar joints are missing or deteriorated and the metal handrails in poor condition on the east elevation porch stair. The lower portions of the handrail posts are rusted to the point where they are no longer structurally sound.

Fig. Ext-06. Porch Stair- East Elevation.

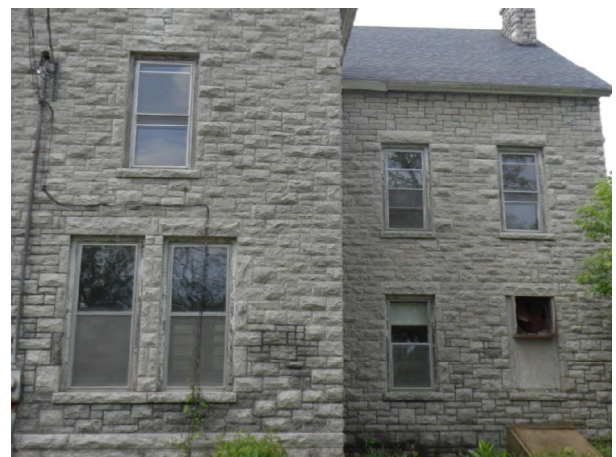
Fig. Ext-07. Stone Deterioration- East Facade.

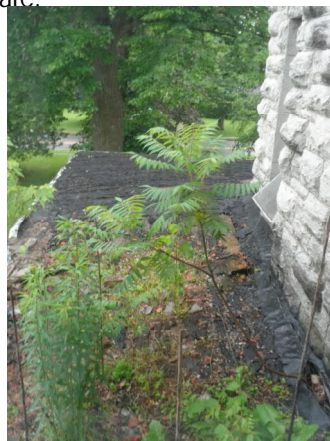
Fig. Ext-08. Porch Roof Vegetation Growth.

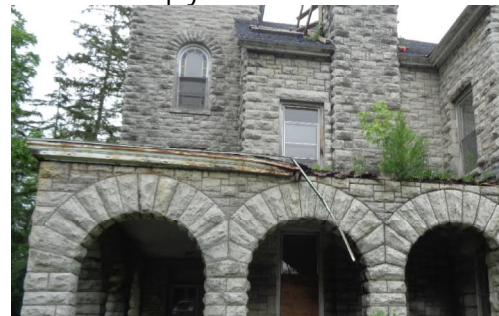
The main roof and the tower roof are composed of architectural grade, shaker style asphalt shingles. Outside of a few isolated areas these roofs appear to be in good condition with no evidence of active water leaks in the attic. However, due to the heavy deterioration of the stone chimneys above the roof line the chimney roof flashings and roof crickets are likely in poor condition or improperly installed. There is vegetation growth at the intersection of the east chimney and main roof. The actual date of the main roof installation is unknown but it should last another 10 to 15 years. There is no evidence that the tower roof or main roof had gutters or any form of rain water management systems. The porch roof is in poor condition. It is currently in a state of active failure with the northern portion above the room 103 door collapsed.

Fig. Ext-09. Porch Roof Deterioration.

Due to the severely deteriorated condition of the porch roof the entire roof system including the wood framing should be removed. Any structurally unsound masonry components should be repaired and a new wood framed sloped roof should be provided. With a new roof deck a single-ply membrane roof should be provided with all associated roof flashings. Finally, all wood cornice should be replaced and trimmed to match the original existing wood, profiles, and finishes.

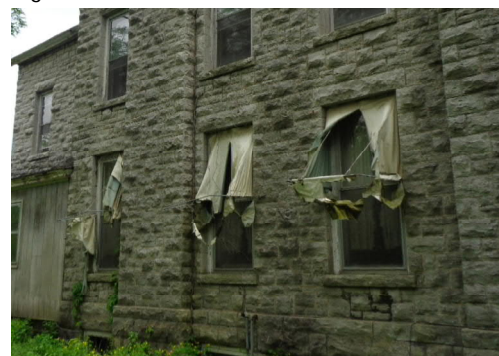
The wood windows range from fair to poor condition. They all have aluminum exterior storm windows that are in poor condition. In all locations the exterior painted finish is in poor condition with peeling paint and exposed wood.

Fig. Ext-10. West Elevation Window Deterioration.

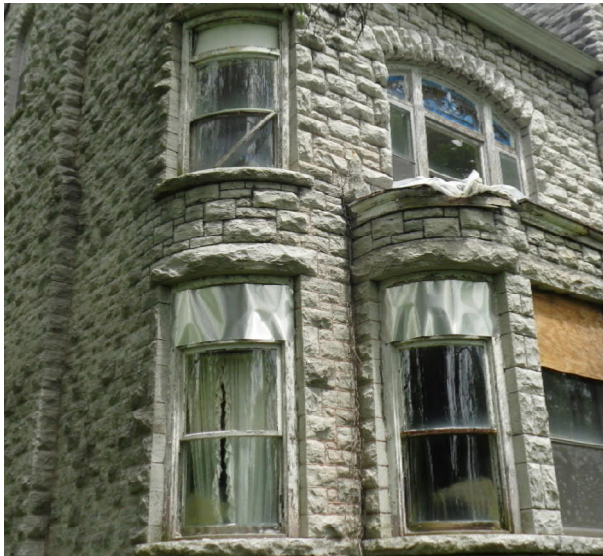
The upper portion of the curved stone bay window on the south elevation is in poor condition. The stone wall above the windows exhibit mortar joints that are deteriorated or missing, and some of the stones have shifted due to the poor condition of the roof above.

Fig. Ext-11. South elevation Curved Bay Windows.

The bay window on the south elevation should have its stone exterior wall removed down to the top of the existing windows. Each stone should be salvaged and number for reuse. All unsound back-up masonry should be removed and replaced. The entire flat roof wood structure should be removed and replaced. The salvaged stones should be reset to recreate the original appearance of the south projecting bay. And final a new single-ply roof

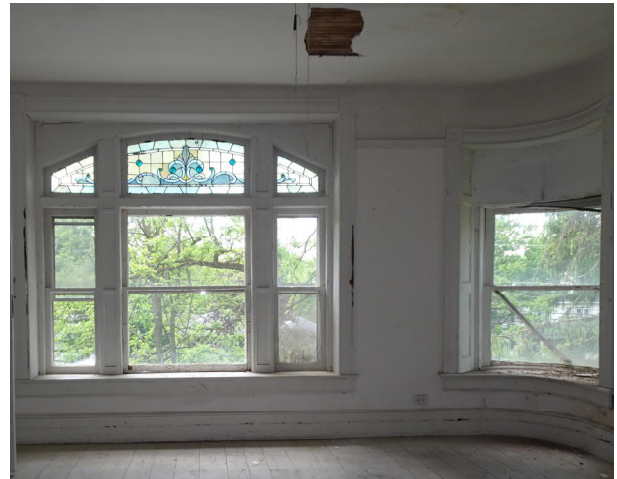
Fig. SF-12. Window Units in Room 215.

- The east window in room 201 is in fair condition with a broken pane of glass.
- The three unit arched window and the curved window in room 215 are in poor condition with deteriorated wood frames, deteriorated wood sashes and missing or broken glass panes due to water infiltration issues.
- The southern window in room 213 has a broken glass pane in the lower sash.

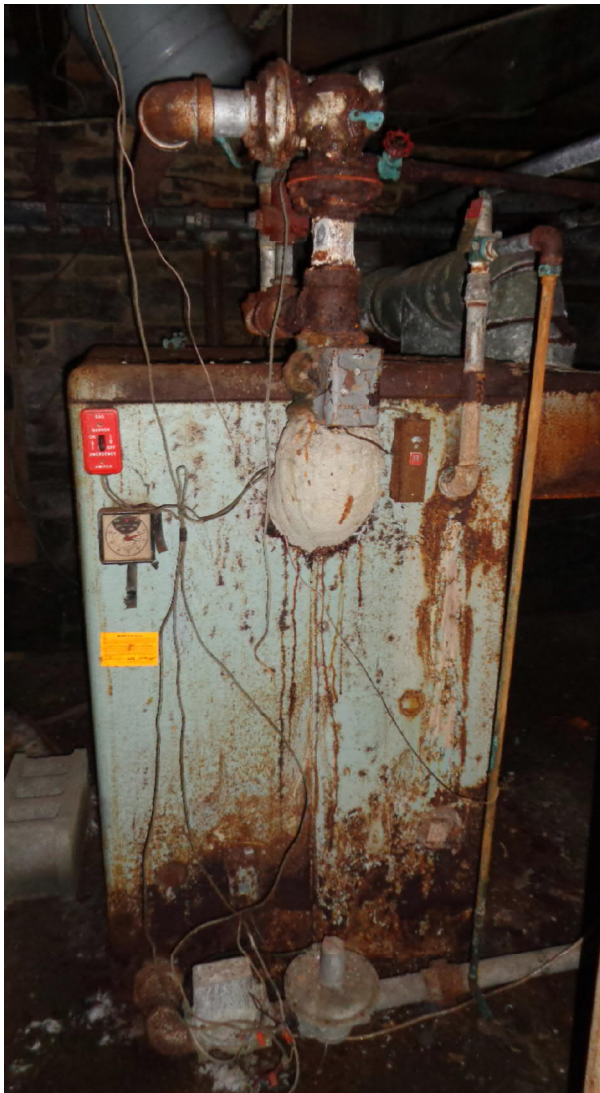
Fig. Ext-13. Hot Water Boiler.

The hot water boiler is located in the southwest portion of the basement and is in poor condition. It is no longer functional. The hot water supply piping and boiler breaching is wrapped in insulation that is most likely asbestos containing material. There is two (2) 100 amp electrical service panels located at the west wall. Both of these panels and associated service and wiring are in poor condition. The sewer line runs in the stone utility tunnel that exits out of the southeast corner of the building.

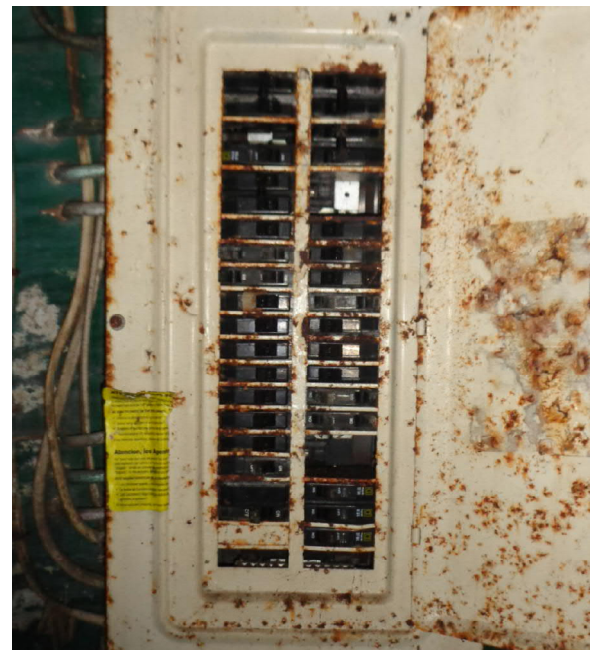
Fig. Ext-15. Electrical Service Panel.

The building has two 100 amp electrical panels located in the basement. In general, the electrical panels and wiring are in poor condition. At the time of the service there is no active electrical service to the building.

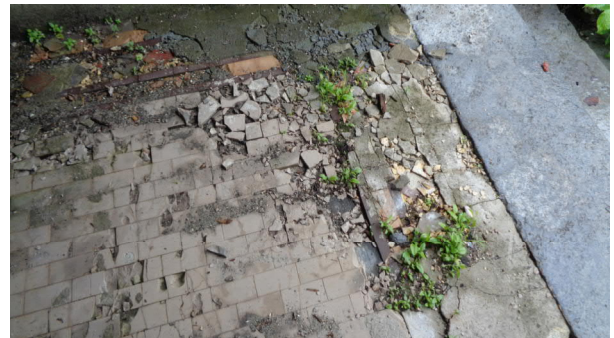
The porch room 100 has endured significant water infiltration for a long time due to the poor condition of its roof. Most of the stone masonry walls are saturated and pointing mortar missing or in poor condition. Along the interior face of the east and south porch stone railing there are numerous stones that have shifted and are no longer in plane with the rest of the wall. The geometric tile floor is in fair to poor condition with many tiles missing, or cracked. The porch subfloor has settled at the side entrance and along the perimeter causing a failure of the tile border and field tile in these areas.

Fig. Ext-17. East Porch Tile Deterioration.

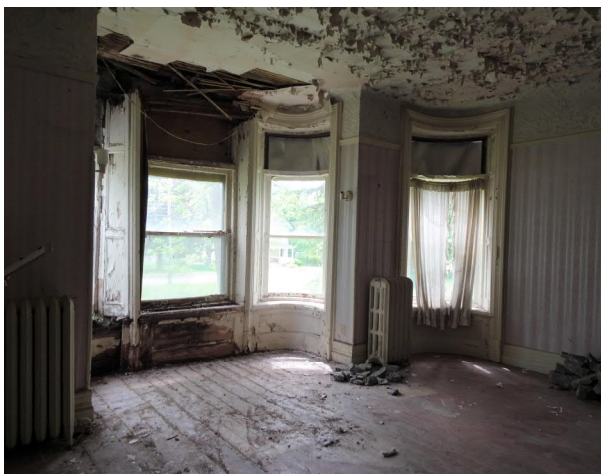
Fig. FF-16. South Bay Window.

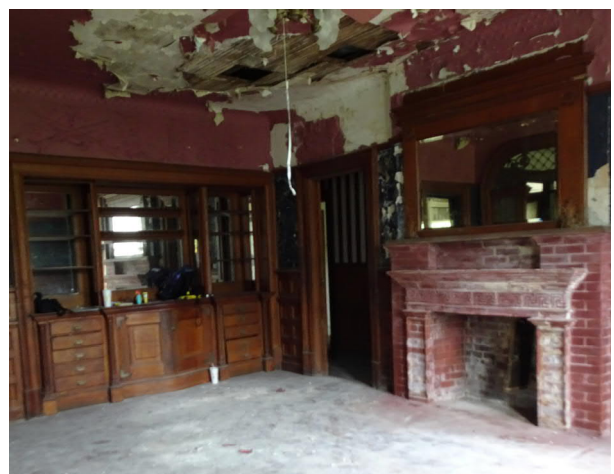
Fig. FF-18. Room 103 Ceiling/Wall Damage.

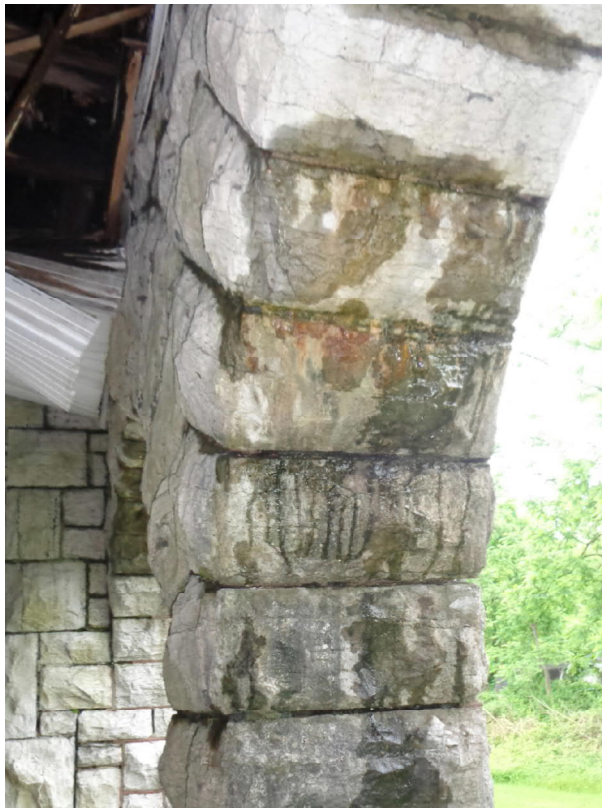
Fig. Ext-19. East Porch Stair Archway Water Damage.

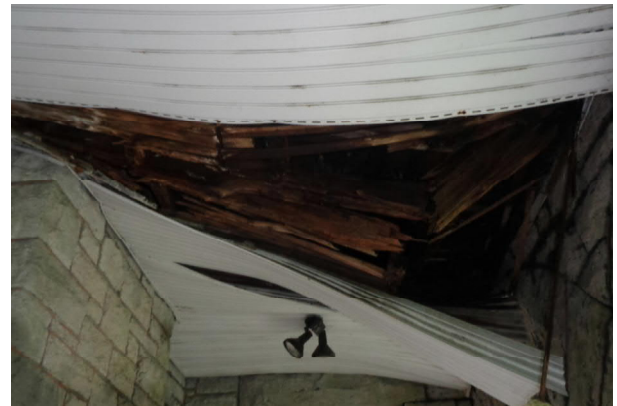
Fig. Ext-21. Porch Ceiling Damage.

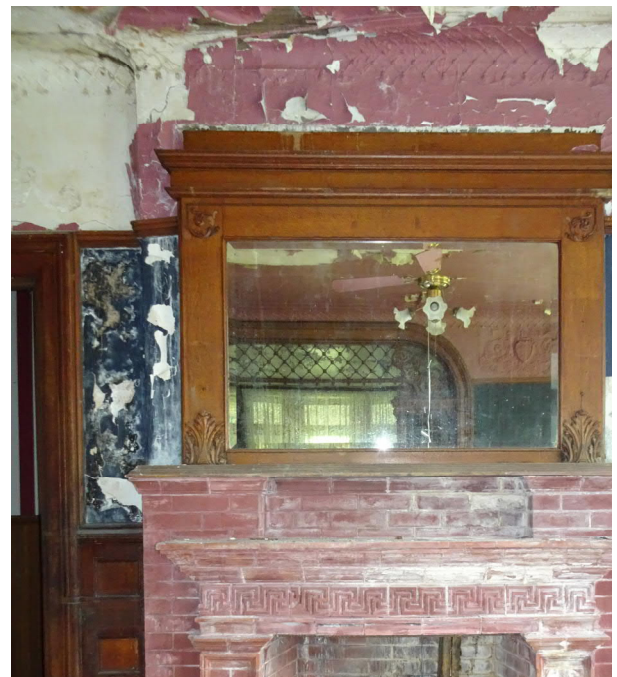
Fig. FF-22. Room 103 Wall Deterioration.

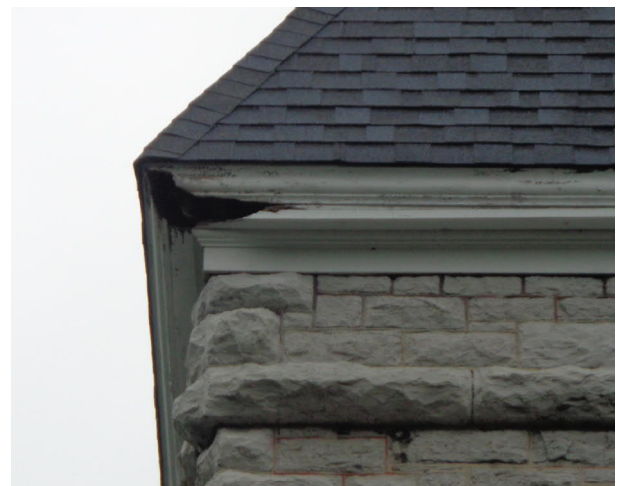
The main roof and tower roof have a wood cornice overhang that is in fair condition. Isolated areas have deteriorated and or are missing that could allow insects and animals into the attic. All of the wood roof cornice finishes are in poor condition with peeling paint and exposed wood surfaces.

Fig. Ext-23. Tower Roof wood Cornice Overhang.

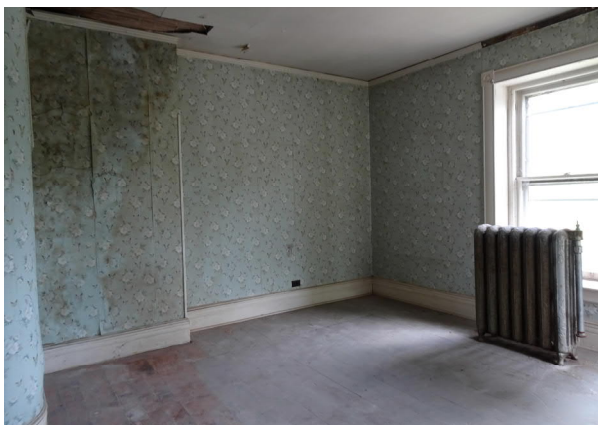
Fig. SF-24. Room 203 Water Infiltration Damage

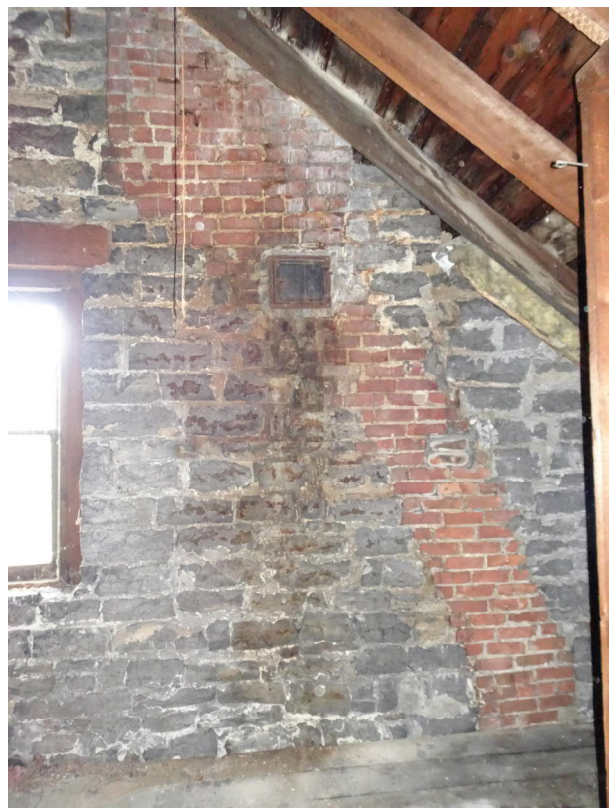
Fig. AT-30. West Attic Wall- Stone Damage.

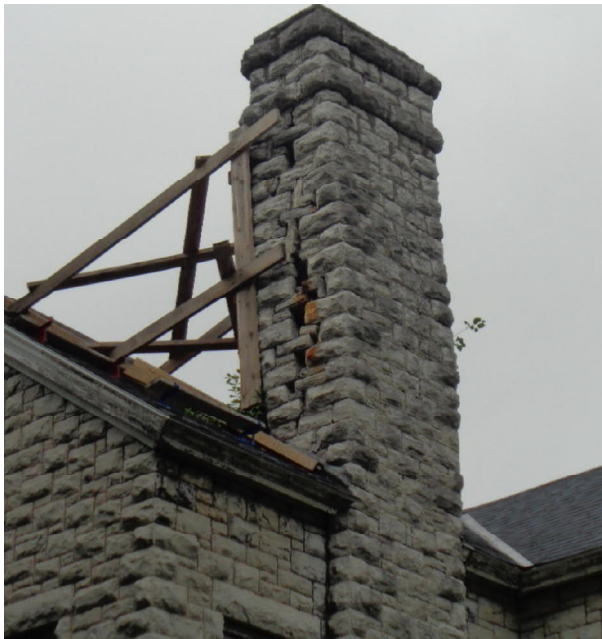
Of particular concern is the condition of all five of the stone chimneys. All of these chimneys are in poor condition with the upper portions of the stone above the roof surface severely deteriorated with large open mortar joints and displaced stones. The worst case is the large chimney on the east elevation above the porch. There was wood shoring installed to keep the chimney from collapse. The entire chimney is listing to the west with visible large gaps in the joints and most of the stones loose or shifted. The south chimney on the west elevation is missing the top twenty four inch-

Fig. Ext-35. Main Chimney Deterioration.

The main chimney on the east side will need to be taken down to the roof level. Each stone number so that it can be placed back in its original location and the brick liner removed. A new brick chimney liner should be provided and the salvaged stones reset. All associated chimney roof flashings and roof crickets should be replaced. A new stone cap should be provided to prevent water infiltration and temporary wood shoring in the attic removed.

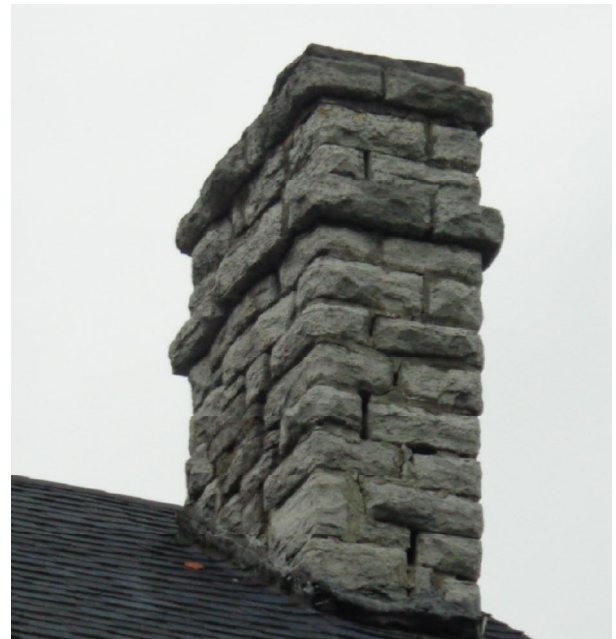
Fig. Ext-36. North Chimney.

The remaining four chimneys should need to be taken down to the roof level. Each stone number so that it can be placed back in its original location and the brick liner removed. A new brick chimney liner should be provided and the salvaged stones reset. All associated chimney roof flashings and roof crickets should be replaced. A new stone cap should be provided to prevent water infiltration.

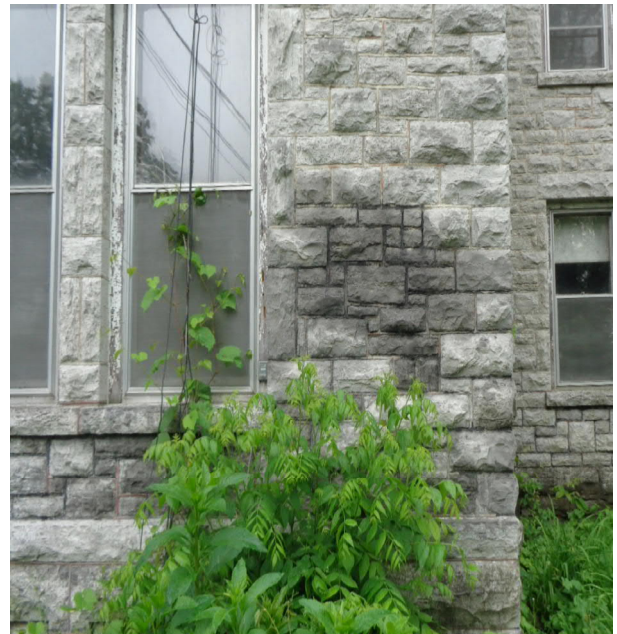
Fig. Ext-39. Exterior Masonry Damage

Scope of work includes spot repointing of the masonry joints, resetting displaced stones at porch, and deep repointing areas at the porch. All repointing work should match the existing grape vine style joint with mortar that is similar to the existing mortar in material, mix proportion and color.

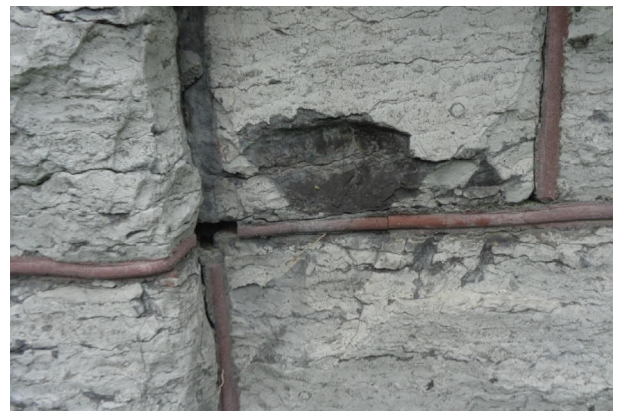
Fig. Ext-40. Exterior Masonry Damage.

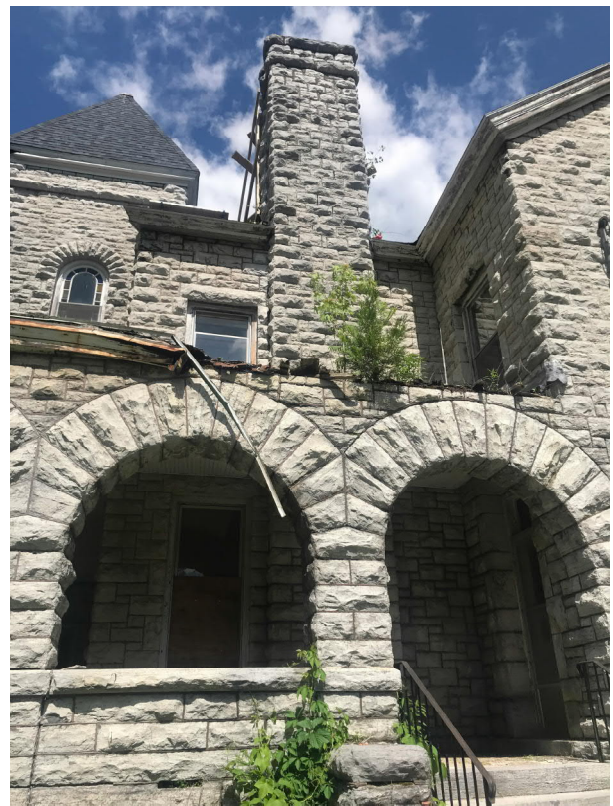
Fig. Ext-46. East Facade- Roof and Chimney Damage
