May 2, 2025

Mold Remediation Plan

Former Alpha Delta Omega Fraternity House
62 Elm Street
Oneonta, NY 13820

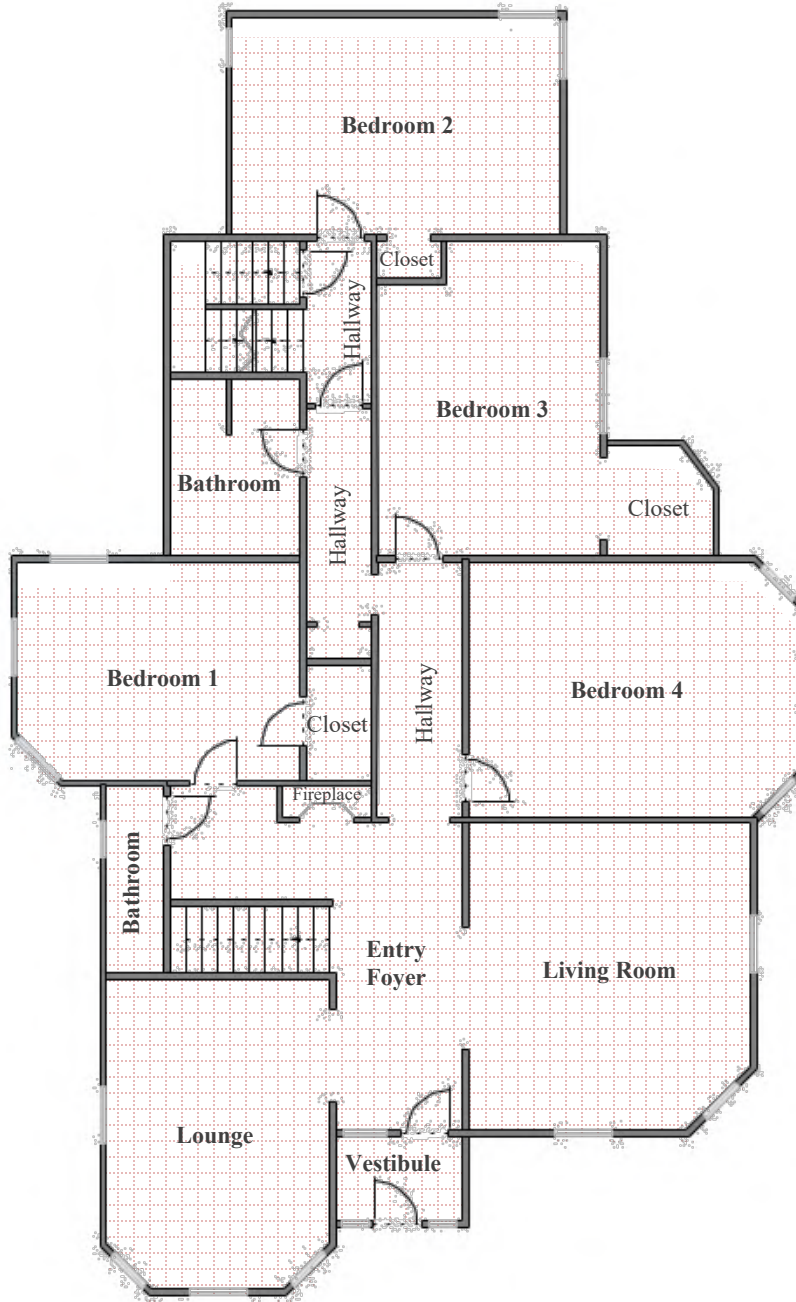
Figure Reference: Mold Remediation Plan

= General areas with visible mold and/or water damage.

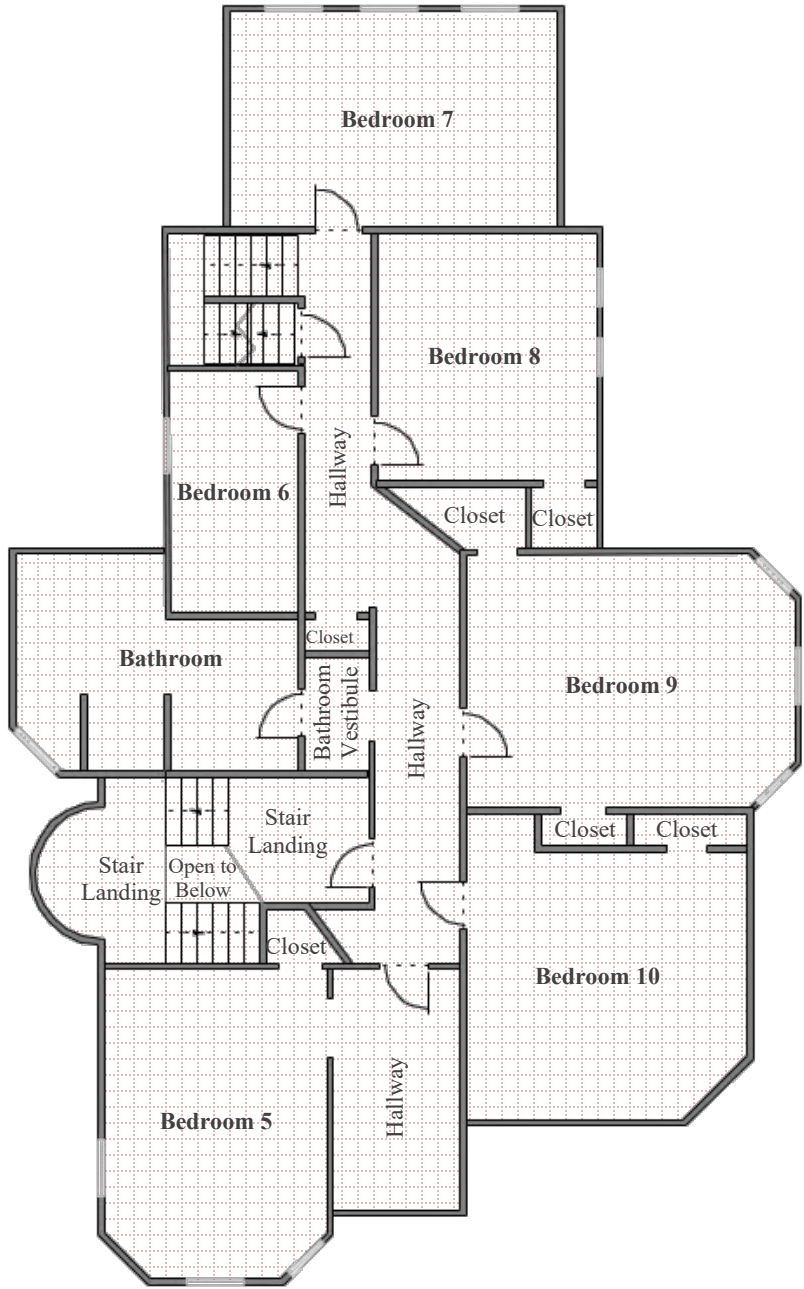
Figure Reference: Mold Remediation Plan

= General areas with visible mold and/or water damage.

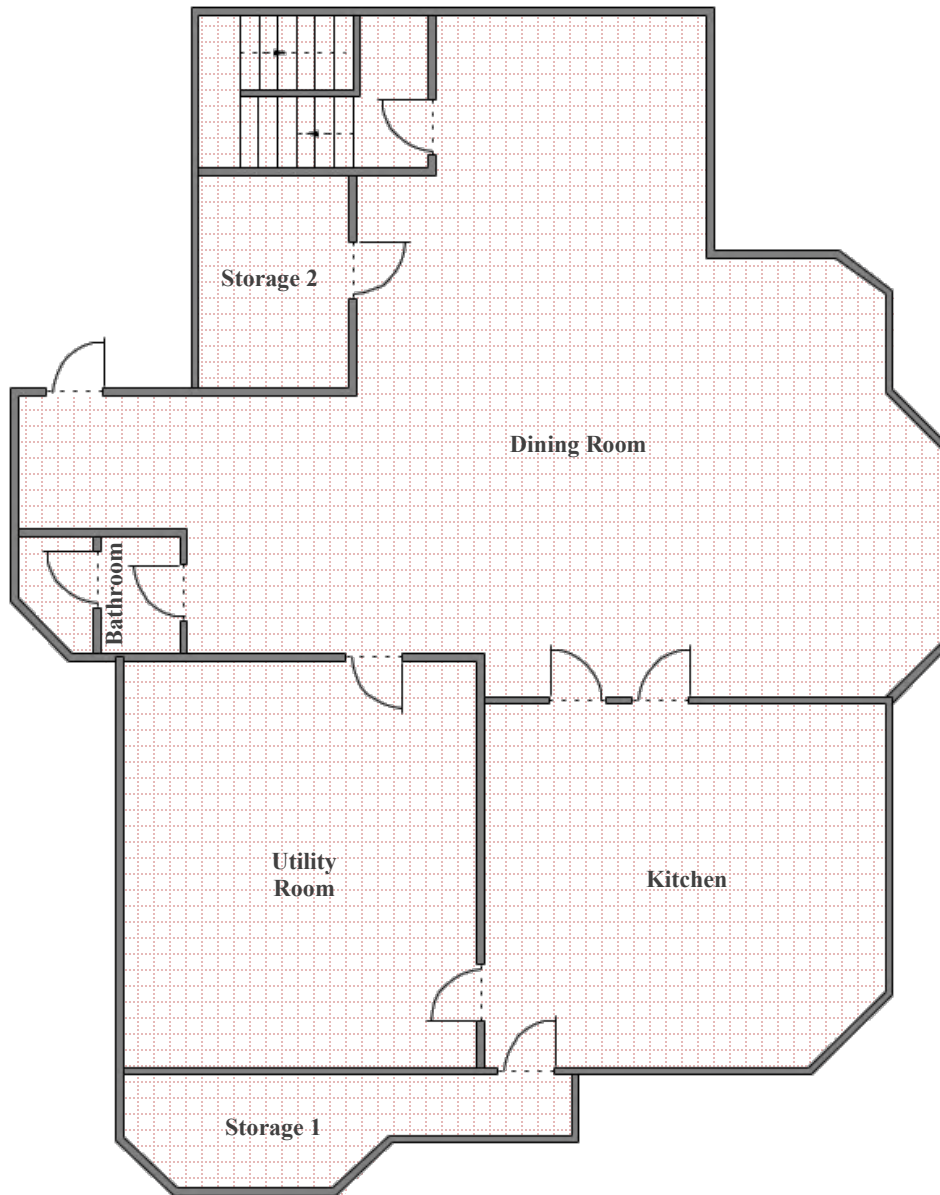
Figure Reference: Mold Remediation Plan

= General areas with visible mold and/or water damage.

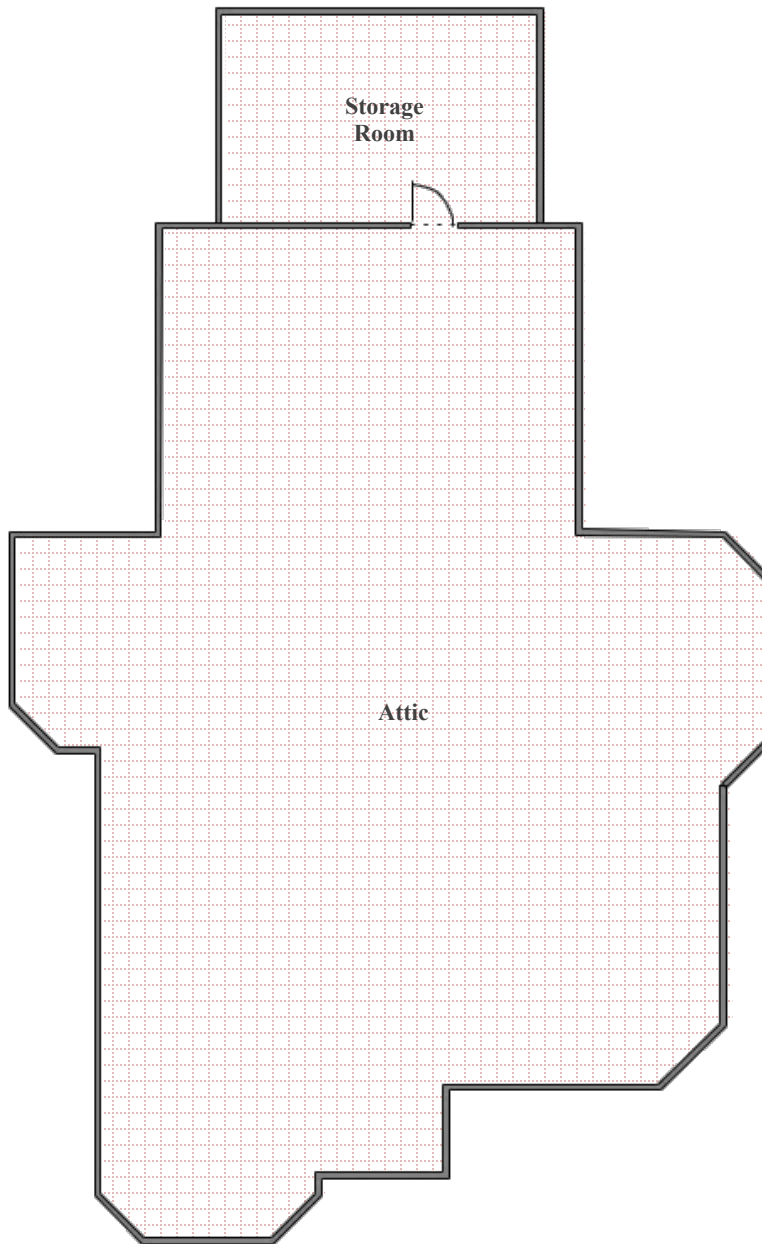
Figure Reference: Mold Remediation Plan

= General areas with visible mold and/or water damage.

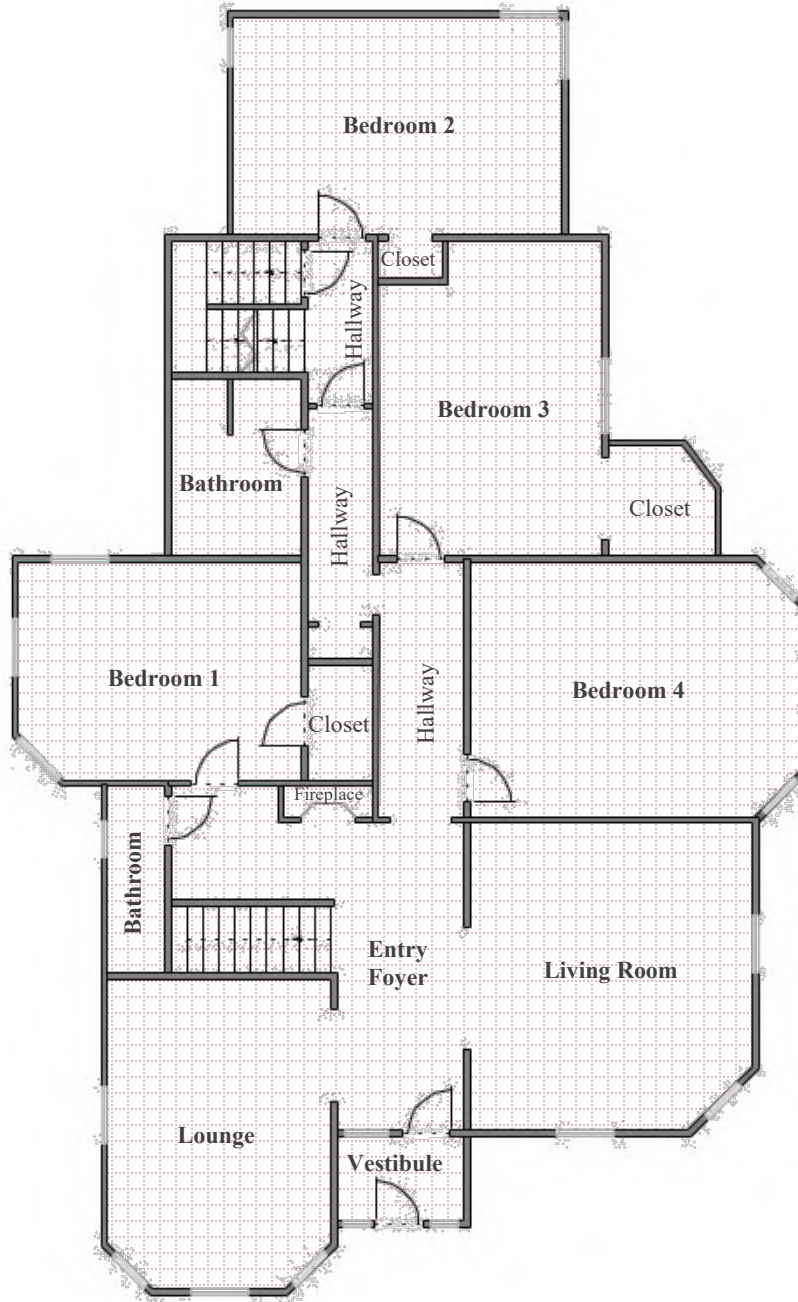
Figure Reference: Preliminary Mold Assessment

= General areas with visible mold and/or water damage.

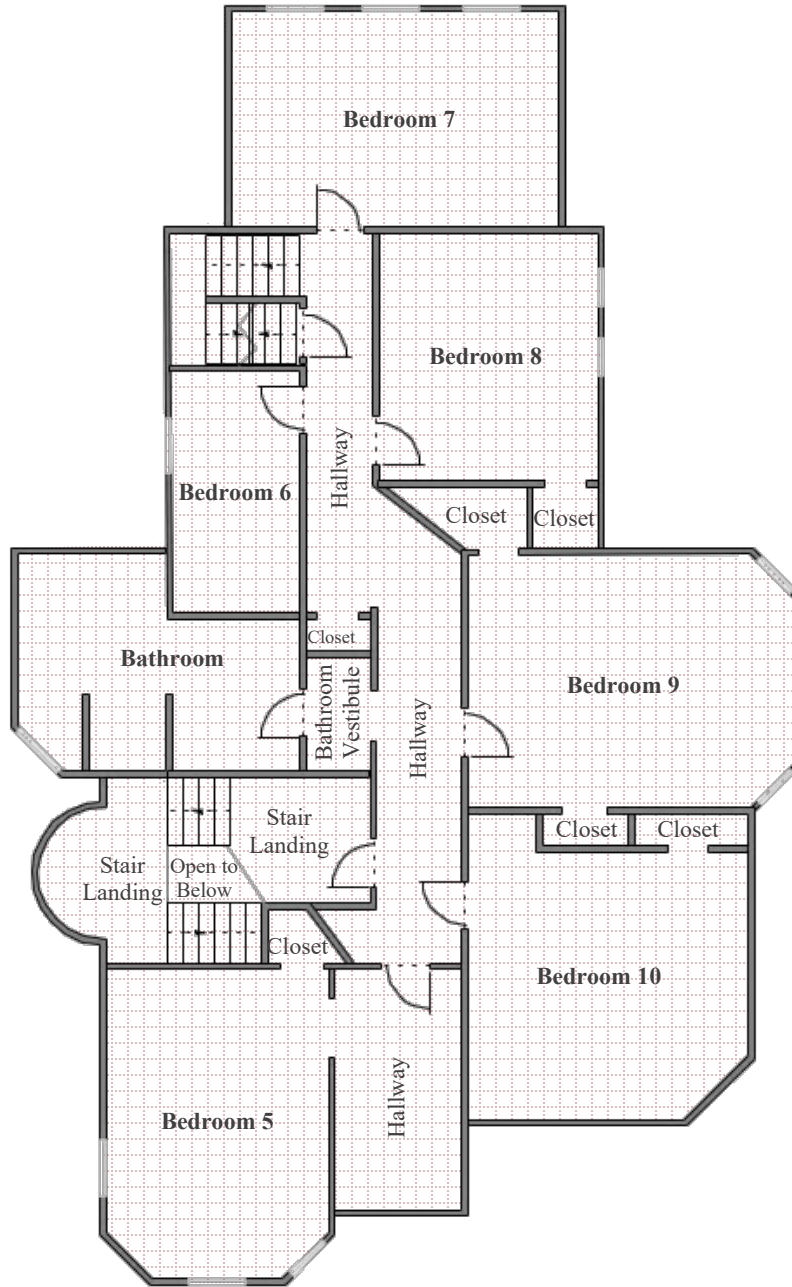
Figure Reference: Preliminary Mold Assessment

= General areas with visible mold and/or water damage.

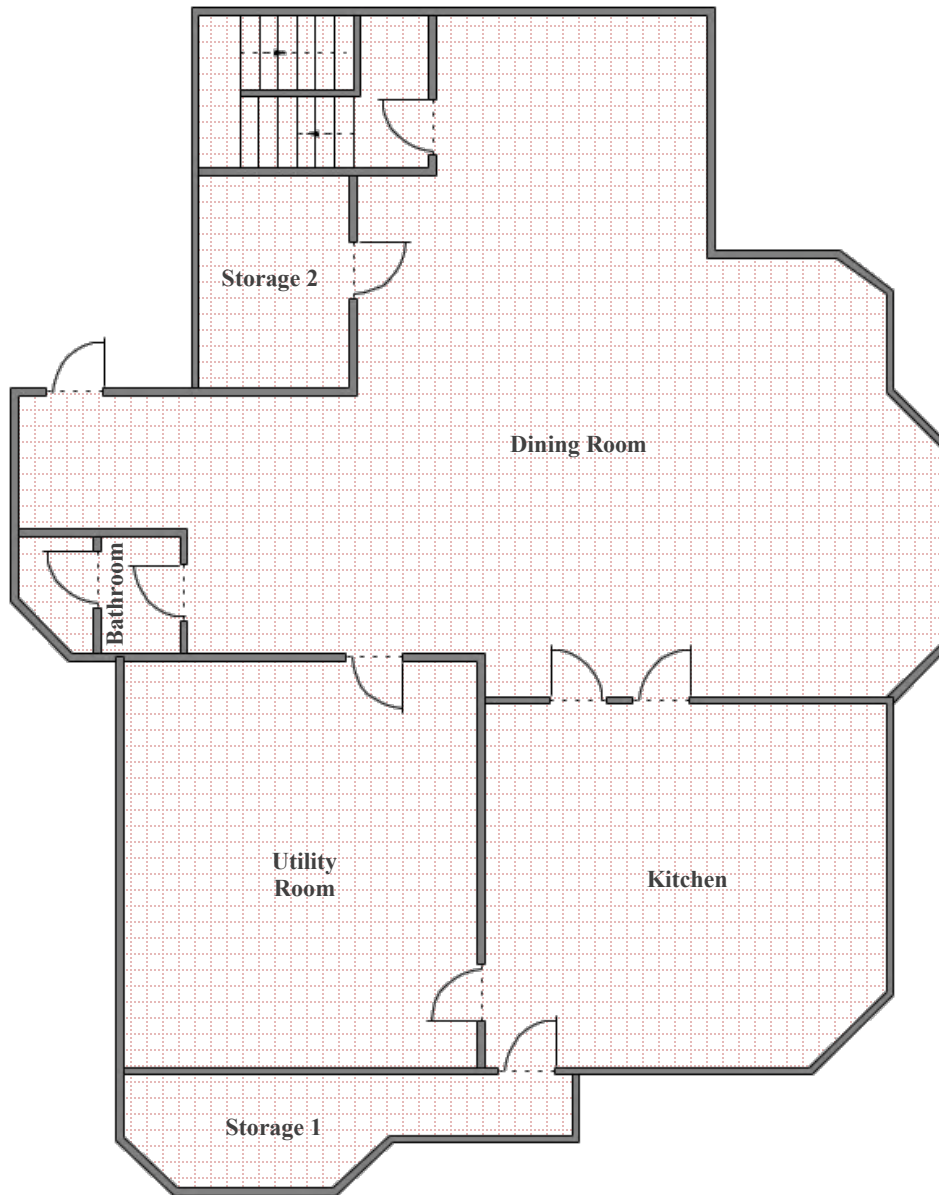
Figure Reference: Preliminary Mold Assessment

= General areas with visible mold and/or water damage.

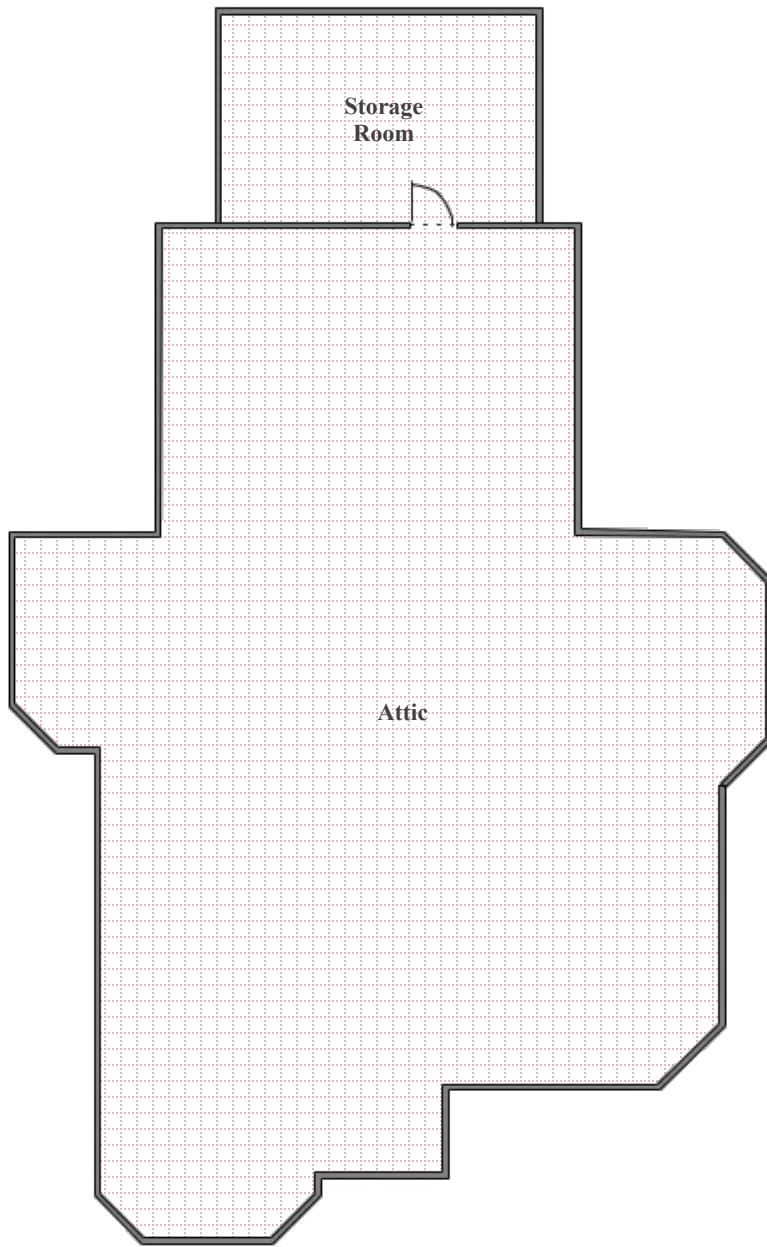
Figure Reference: Preliminary Mold Assessment

= General areas with visible mold and/or water damage.

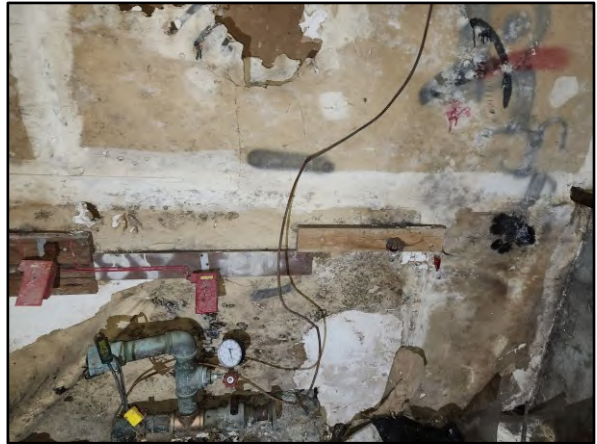
Mold on drywall wallboard in the basement.

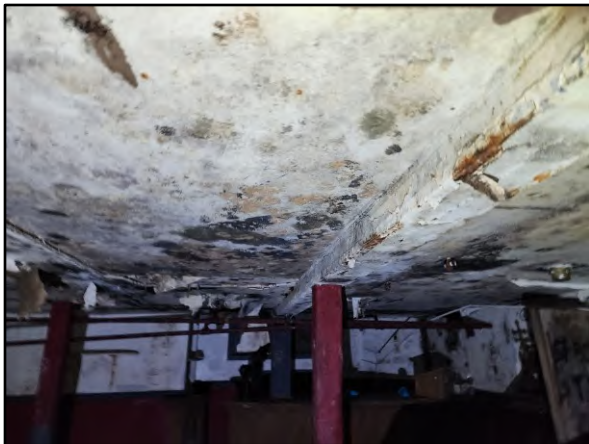
Mold on the drywall ceiling in the basement.

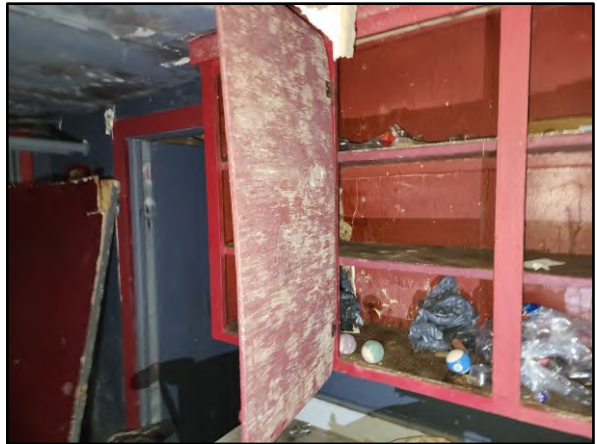
Basement cabinets with visible mold.

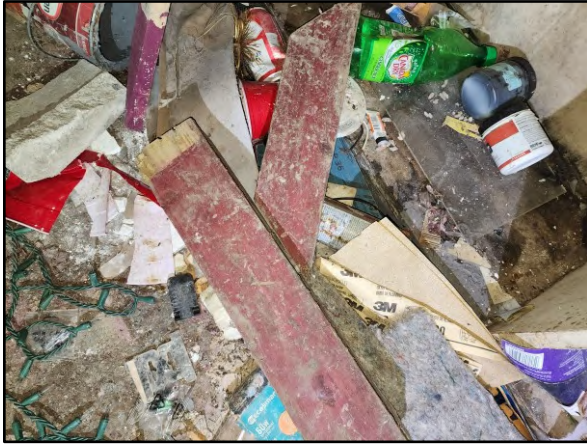
Debris on basement floor with visible mold.

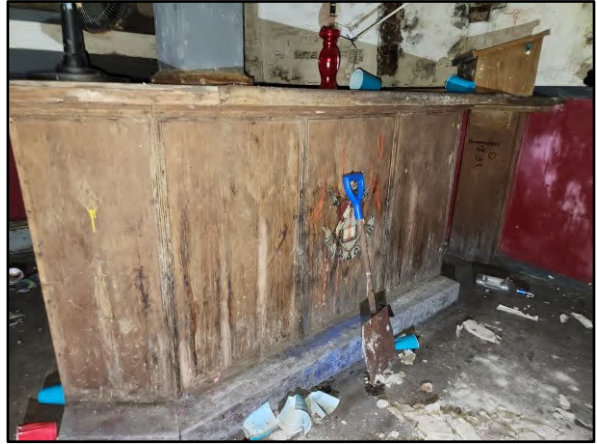
Bar in basement dining room with visible mold.

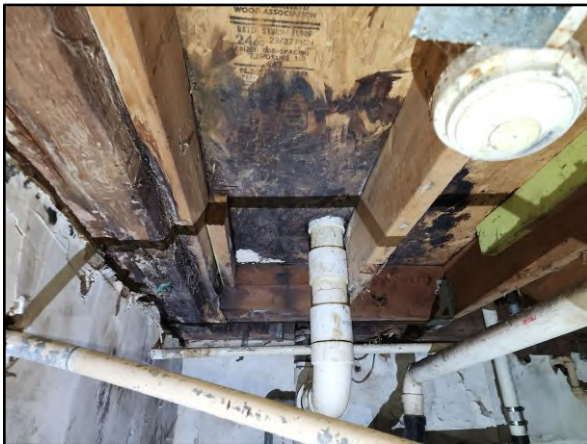
Visible mold on OSB ceiling board and framing in basement storage room 2.

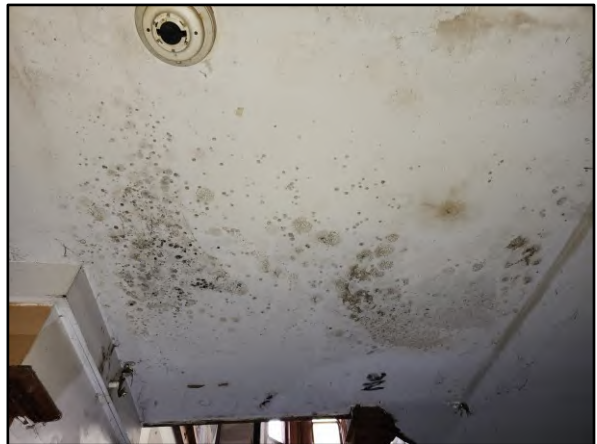
Visible mold on the ceiling of the first-floor entry foyer.

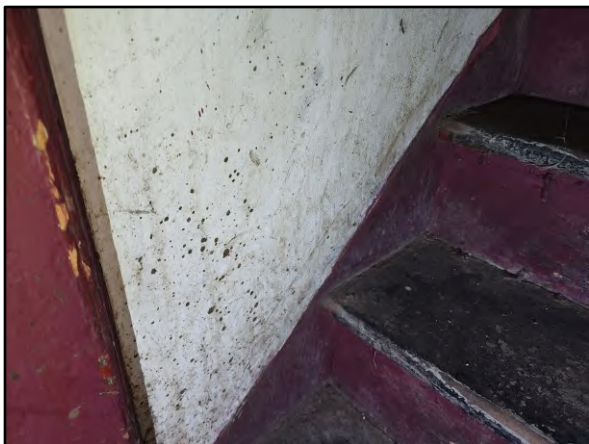
Visible mold on drywall wallboard at back stairs.

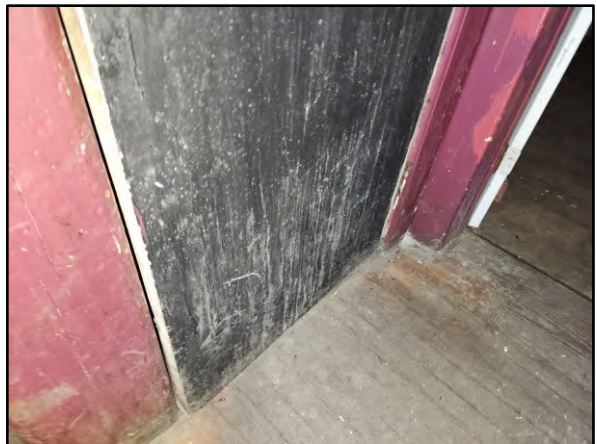
Visible mold on wood door on the first floor.

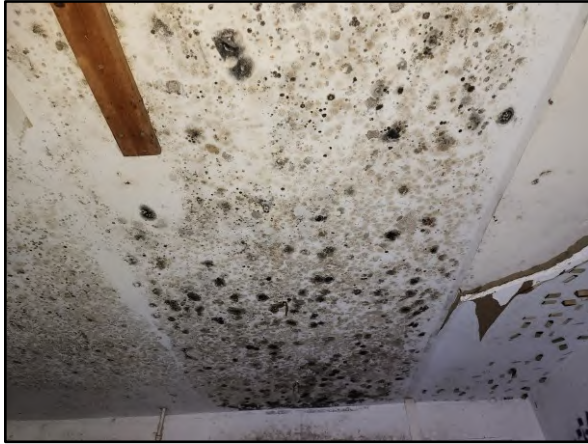
Visible mold on the ceiling of Bedroom 3 on the first floor.

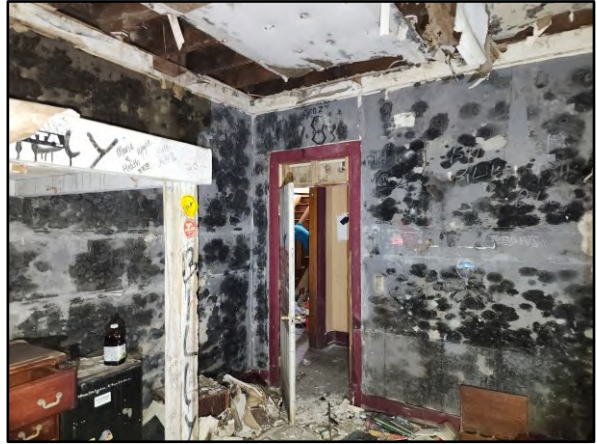
Visible mold on the walls and ceiling of Bedroom 4 on the first floor.

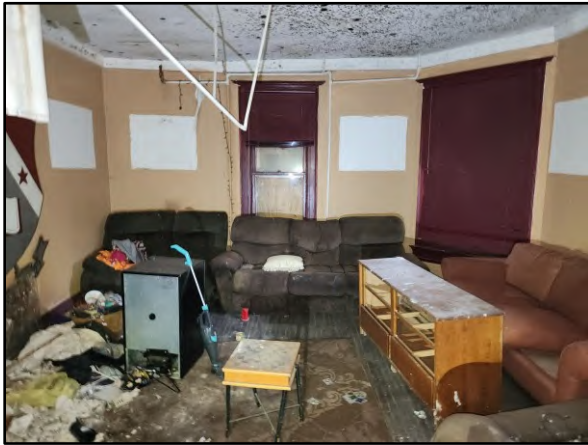
Visible mold on the ceiling of the first floor living room.

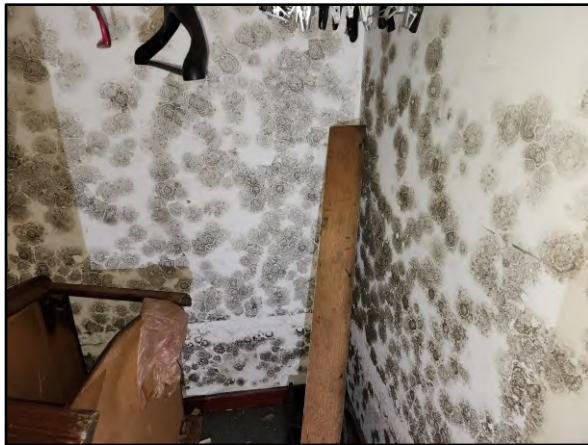
Visible mold in the closet of Bedroom 9 on the second floor.

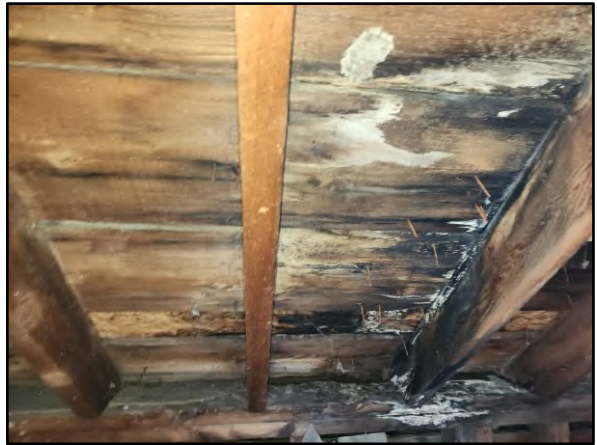
Visible mold on the roof decking and framing in the attic.
